## CONSERVATION AND RESTORATION OF THE MURAL PAINTINGS FROM THE CHILDREN'S CHAPEL IN THE CHURCH OF ST JAMES, KING STREET, SYDNEY

### LOOKING FOR THE METHOD OF TRANSFER

Anna Diakowska-Czarnota and Arek Werstak

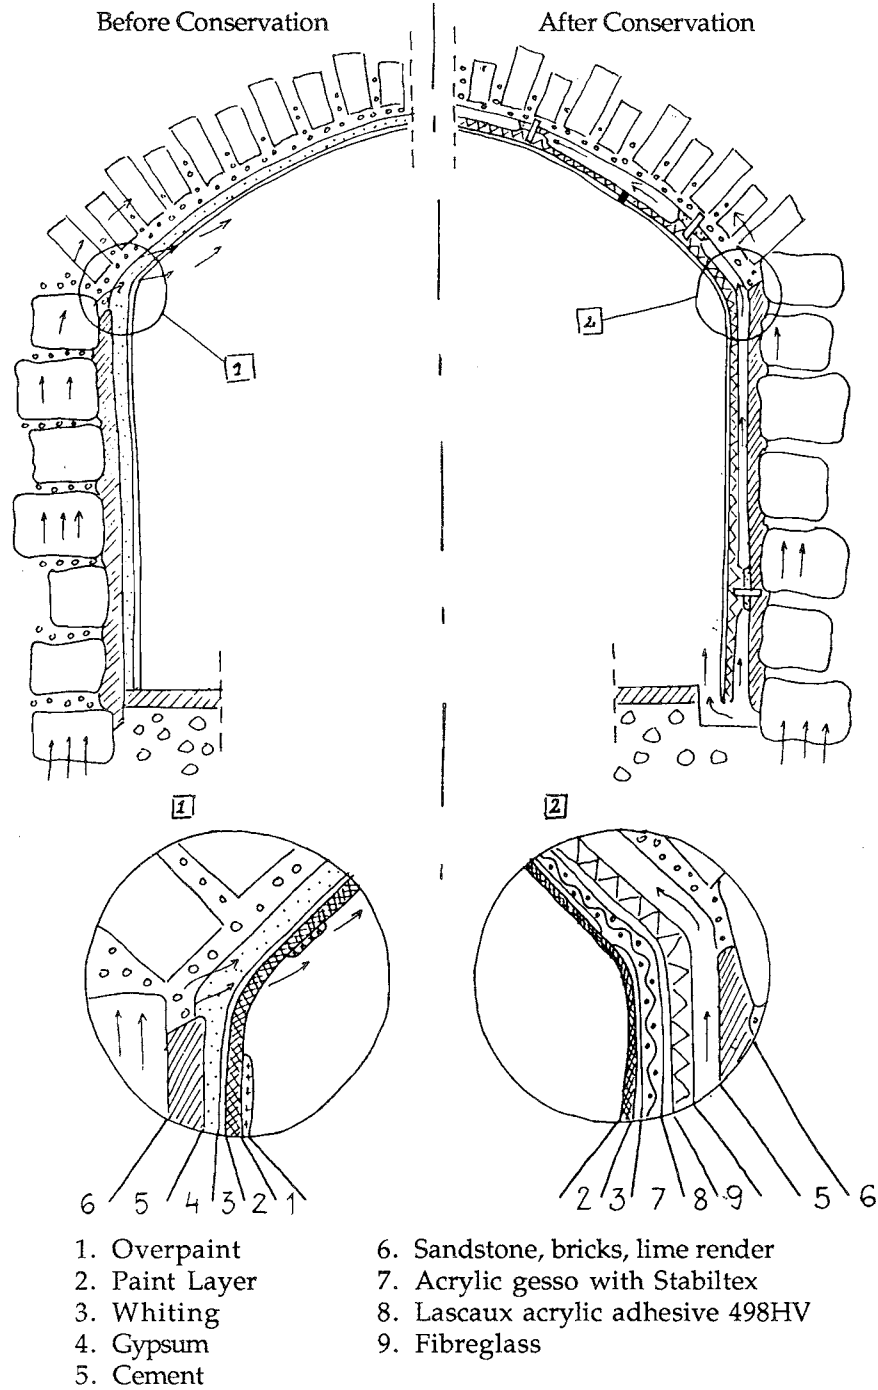
The medium was identified as a proteinaceous substance, most likely to be a casein tempera, painted on a thin layer of polished gypsum, with an interlayer of glue-based whiting. The gilding was applied onto a coloured glue size. The support for the paint layer on the walls was different than that in the vaulted area. The lower walls, to a height of approximately 1 m, were constructed of sandstone block, covered by a cement render, followed by gypsum, upon which the paint was laid. The vaults were constructed of bricks covered by a lime render of varying thickness, followed by the gypsum (Figure 1 and Illustrations I & IV).

The sandstone construction built over an underground stream resulted in moisture being drawn up the walls, evaporating at the earliest opportunity, crystallising the salts on the surface or between the layers of the murals' construction (Figure 1). The cement render on the lower part

FIGURE 1  
The scheme of technical structure of mural from St James Church.  
State before and after conservation.

removed. This allowed 9 mm of free air space. The fibreglass and the air space were necessary to assist in drying out the walls and to act as a physical barrier to future salt damage (Figure 1 & 4).

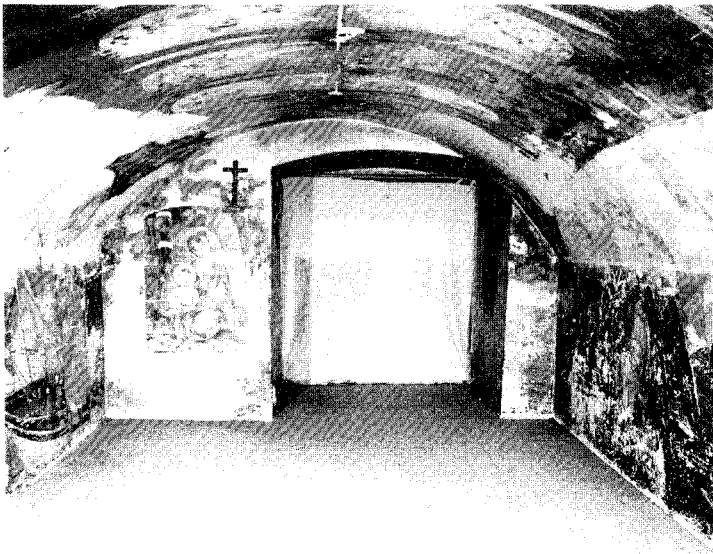
ILLUSTRATION I  
*Before conservation*  
View on the south wall.

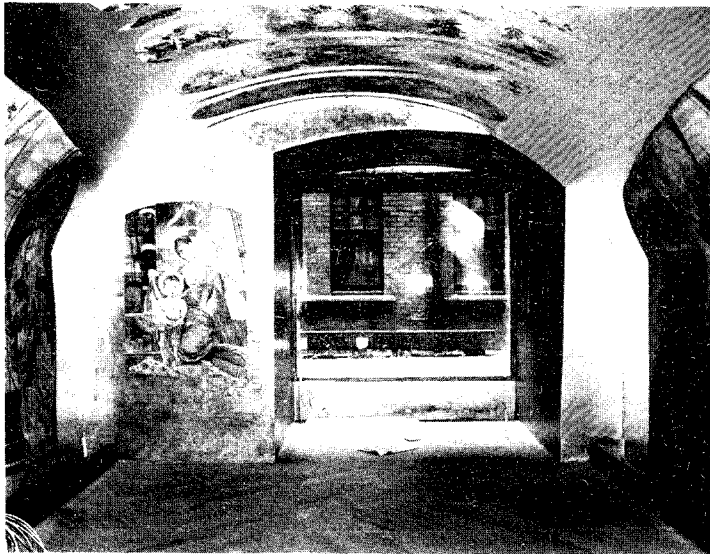
ILLUSTRATION II  
*After conservation*  
View on the south wall.

Inpainting and reconstructions were done in such a way to blend with the surrounding original paint to give a general cohesion of design and style because the murals are viewed at close quarters (Colour Plates 1 - 3 and Illustrations II & III).

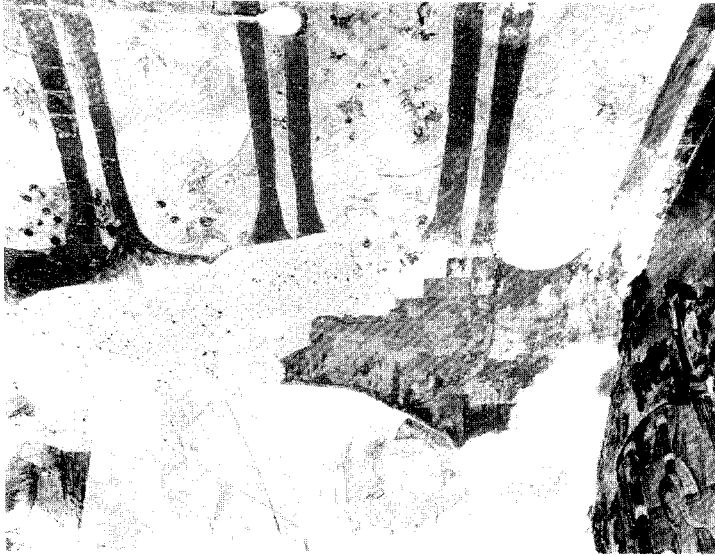
ILLUSTRATION III  
*Before conservation*  
East part of vault.

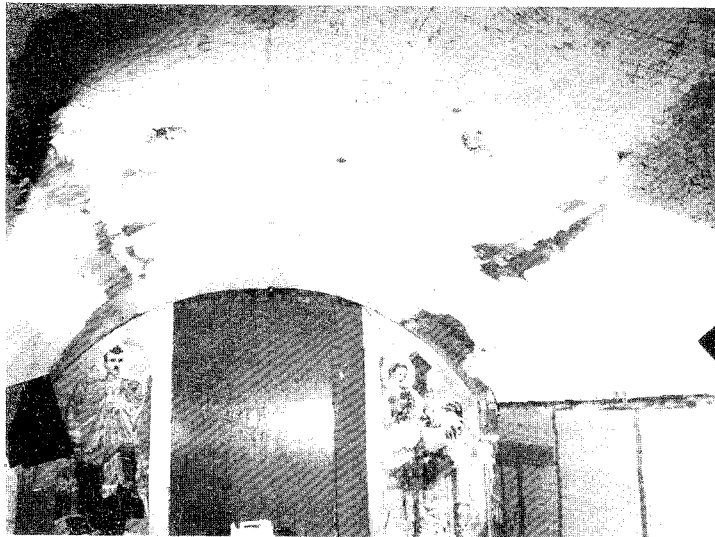
ILLUSTRATION IV  
*During conservation*  
Vaulted ceiling after  
mural removal.  
Visible original lime  
render and left  
fragments of gilded  
background.

The area to be removed was cut through in designated areas following the edges of the design, where possible, to a depth that would release the paint and gypsum layers at the lime render interface (Figure 3). Each piece was removed by first tapping with a mallet to dislodge the bond at gypsum/lime render interface, then by prising apart with round-end palette knives of varying lengths. During this process the piece being released was supported by a light weight polystyrene and plywood support curved to the shape of the vault. This was used to transfer the piece onto the 'working support', a more rigid curved structure used to provide a strong working surface whilst the gypsum was scraped from the back of the paint layer (Illustrations IV & V).

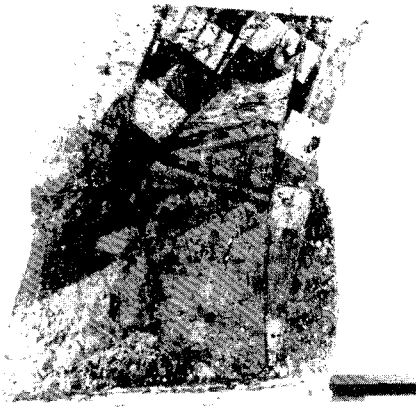
ILLUSTRATION VI

Fragment of paint layer from the west wall visible from back. State after gypsum removal and during consolidation from back with Paraloid B72 in xylene 2.5% W/V. Paint layer and leaves of gold are visible after saturation with solvent.

After gypsum removal, the consolidation of the back of the paint film was made with Paraloid B72 in toluene (2.5% W/V). Whilst the back was saturated, the underdrawing could be clearly seen (Illustration VI).

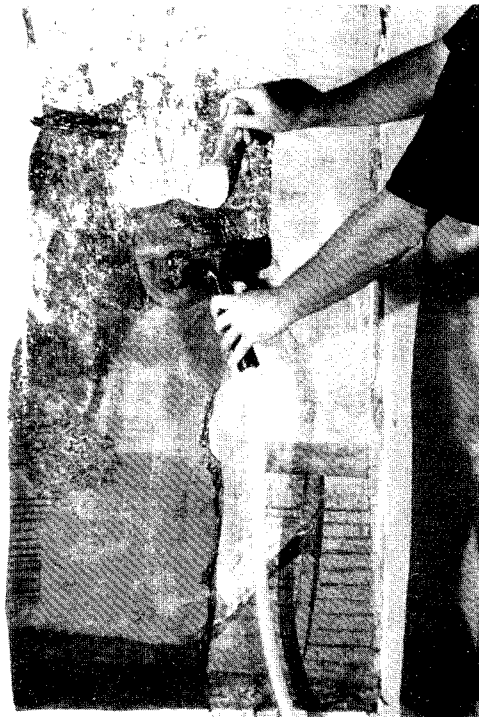
ILLUSTRATION VII

Fragment of mural painting from west wall during facing removal with steam gun.

After applying the gesso with the Stabiltex, the facings were removed using a steam gun and sponging with water to remove any residue of the colletta from the paint surface (Illustration VII). Each piece was then placed between felts and left to dry under weights. This eliminated a tendency for the acrylic gesso to shrink slightly after steaming.

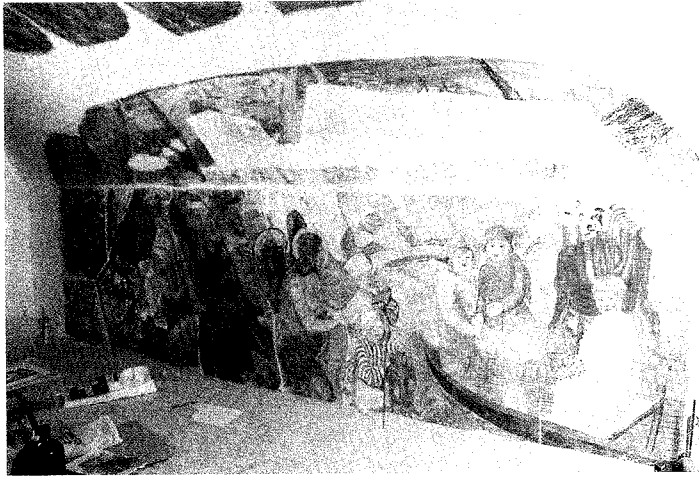
COLOUR PLATE 1  
*During Conservation*  
The painting from the west wall after transfer onto fibreglass, placed in chapel. Visible white, acrylic in-fillings and drawing done as introduction for the painting's reconstruction.

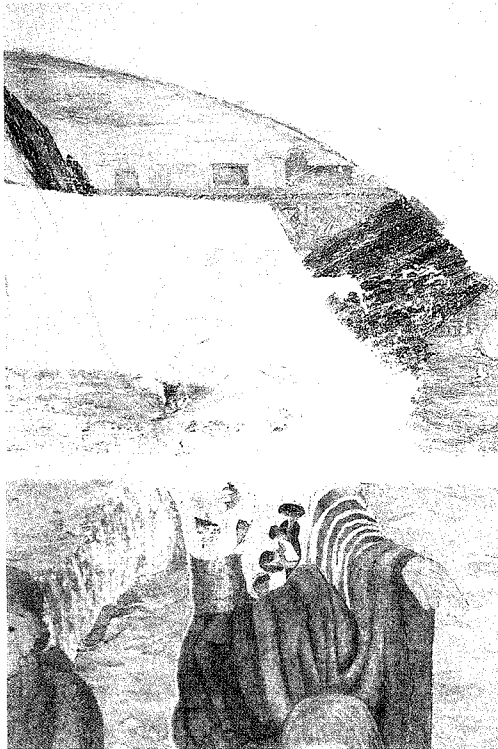
COLOUR PLATE 2  
*During Conservation*

Drawing: Detail of Angel from the west wall.

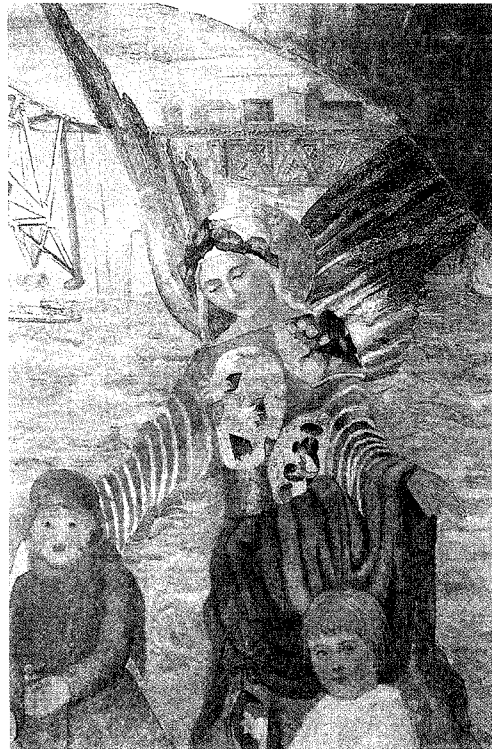
COLOUR PLATE 3  
*After Conservation*

Detail of Angel from the west wall.

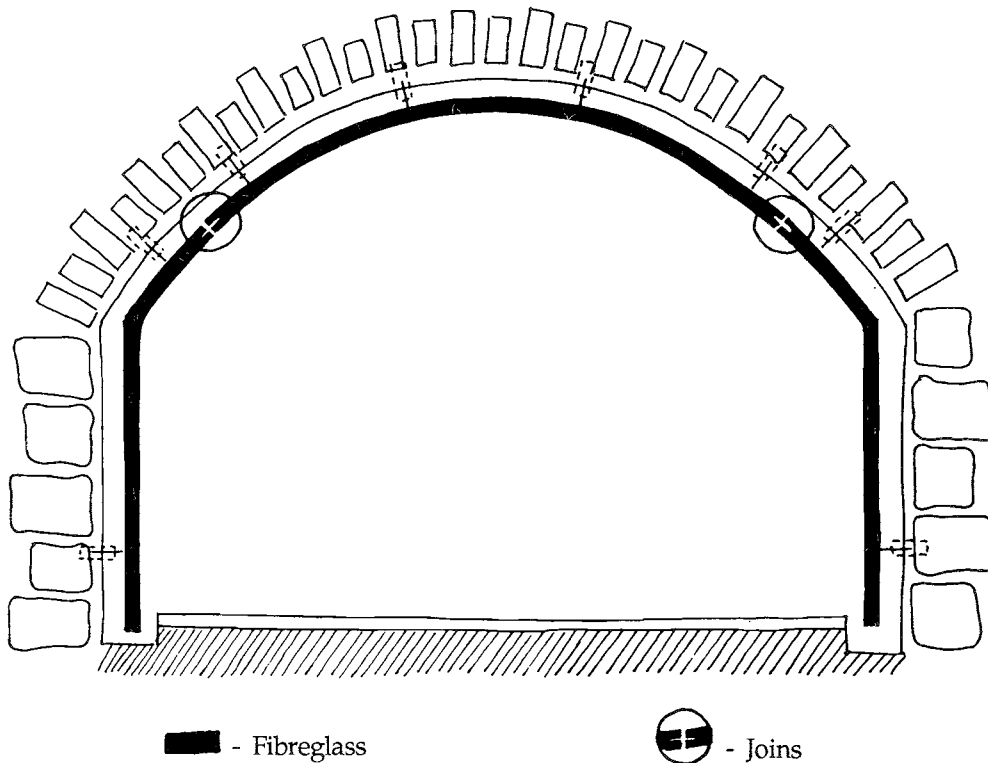
FIGURE 2

The scheme of location of joins between three parts of fibreglass.

The vaults were to be removed in small sections from three different areas: the top parts of the east and west and the central ceiling section, that had been painted as if looking through the framework of a gilded ceiling. The gilding had been so overpainted and damaged that it was considered that the background gilding of the east and west walls and the vaults would need to be replaced. This provided a sacrificial area for the cutting, allowing the panels to be taken out in smaller sections for ease of handling and an area for joining the new rigid three sectioned fibreglass support. The support had to be sectioned to permit installation through the restricted sizes of doorways and corridors in the crypt (Figure 2).

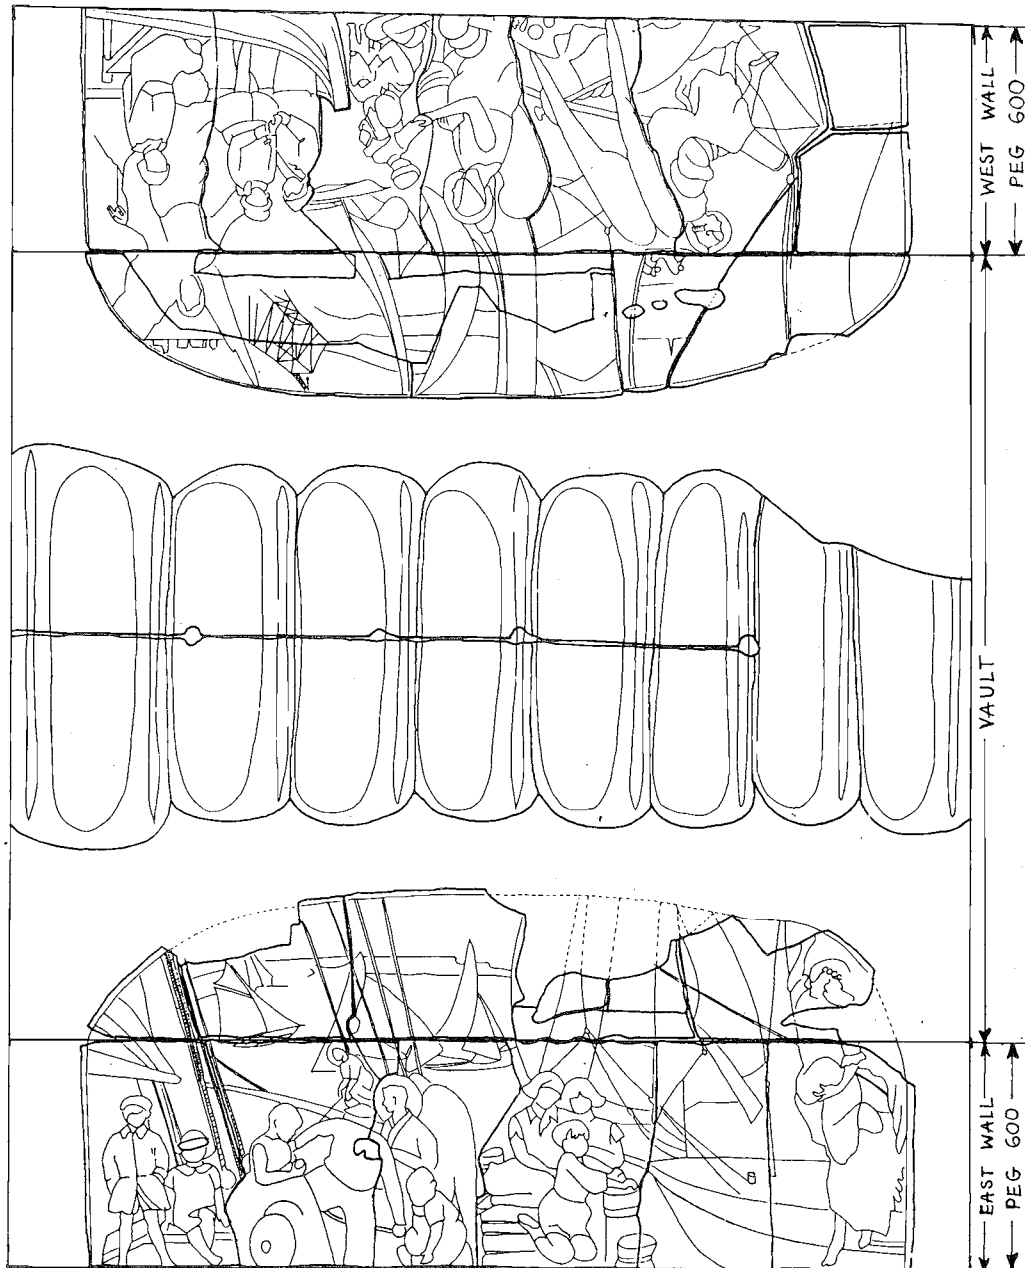
FIGURE 3  
Drawing of the composition of the painting on the East and West walls and the vaulted ceiling. Location of cuts, and areas where PEG 600 was used.

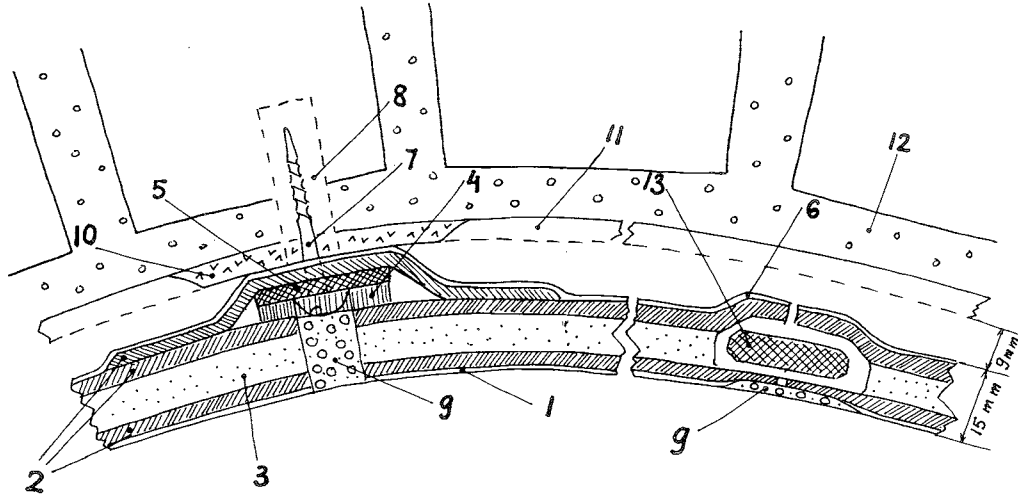
FIGURE 4  
The scheme of structure of fibreglass and method of joining.

The fibreglass shell, made from fibreglass and isophthalic polyester resin with an interlayer of 10 mm thick rigid polyvinyl chloride foam, was made in three sections to the exact shape of the Chapel vault and walls. The structure is supported by stainless steel ribbing for strength and rigidity. In the report to St James Parish confirming treatment, it was proposed the lime render and concrete be removed from the walls and vault where the mural had been removed in order to create space for the new support and an airspace between the support and the wall to assist in drying it. However, permission to remove the render was withdrawn by the architect. This necessitated the fibreglass shell's reduction. Reductions were made in the gold area rather than the painted area along the two horizontal joins between pieces. This join was reinforced with inner stainless steel bars and was sealed with polyester resin putty (Figure 4). The fibreglass was attached to the wall with stainless steel screws into plastic raw plugs. The holes above the screw heads were filled with polyester resin putty. Their location, dictated by areas of loss to the original painting, is fully documented. The fibreglass shell was applied to 10 cm x 10 cm square pads of the new gypsum, which were left after replastering in areas corresponding to attachment sites. All the rest of the new gypsum was
